Site Inspection, Ziegler Mining Company, Hardaway #1 Project, S/047/072, Uintah County,

Date of Inspection:

May 15, 2001

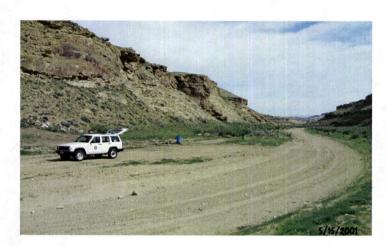
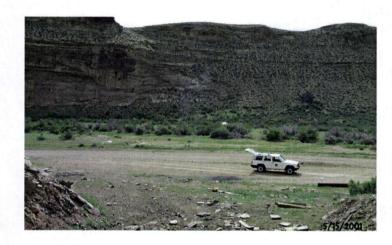
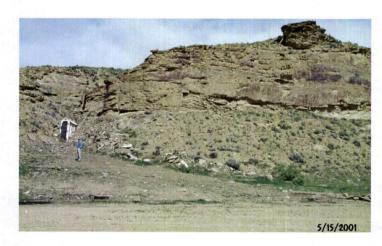
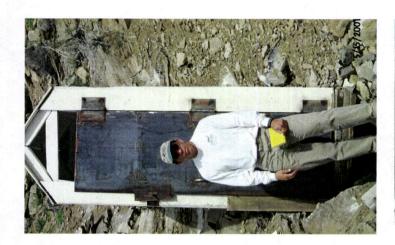
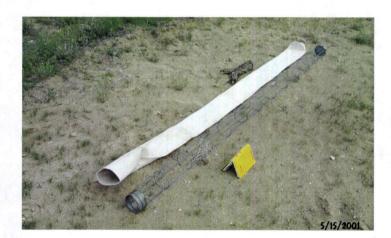
## FIEGUER HARDAWAY 9/047/072

This mine site is located immediately adjacent to the main access road. No one else was present at the site at the time of this inspection. Features at the site included wooden planks, wooden stull pieces, a section of metal pipe, two 55-gallon barrels, and a metal door leading into the side of the gilsonite vein. The metal door was closed, but not locked at this time. One of the 55-gallon drums contained trash and the other was an empty fuel drum. A GPS point was taken at the site under the name of s47-72. Photographs were taken to document the current status of the site.

The site disturbance was approximately 100 paces long and 40 paces wide. There was an additional small disturbance across the main road (south side). Other features at this site include a rough two-track road leading up the hillside to the top of the vein. The two-track road leads to an old trench excavation on the vein and two smaller trenches that also appear to be old disturbances. Partway up the hillside was an old pile of gilsonite

In conclusion, the site appears to be in a state of suspension, or final phase of cleanup after mining. The remaining trash and debris should be removed from the site, and the metal door secured during any extended suspension.
